# CASE STUDY: INDUSTRIAL DRIVESHAFTS FOR A380 FIRE FIGHTING SERVICE

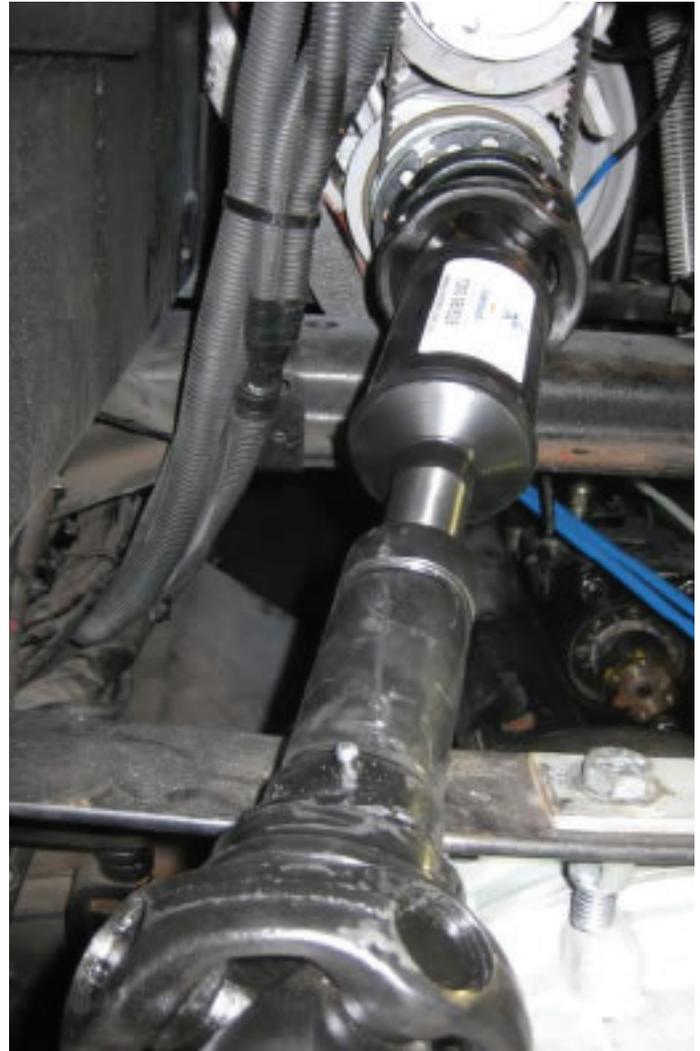
After manufacture the unit was taken on site where it was to be fitted to the fire fighting vehicle. However, it was found that the hardware used to fasten the shaft on the mating PTO and pump flanges did not allow the shaft to freely rotate. There were too many protrusions from the knuckle casting that were contacting the fastening nuts to the flanges. It was evident that this was a design flaw in the existing CV itself.

The Indrotech team of engineers at the fire station workshop resolved this problem by deciding to physically shift the water pump across the vehicle chassis, directly in line with the PTO unit. This would reduce the excessive driveshaft angles and ensure the

hardware would not fail on the casting. After several days of modifications the shaft was refitted, and as planned it was free to rotate as expected. Once the fire truck had been fully modified and the shaft refitted it was test run under full load conditions and performed as designed. The unit ran smoothly without the CV joints jolting, even though the angles were still severe. There were also no vibrations due to the extreme angles thanks to the tight balance grade achieved by Indrotech's Schenck CAB840 balancing machine.
